## PA/VSİ Or RFA FILE REVIEW CHECKLIST

Facility Name: Grede Foundries, Inc.

Re: Visual Site Inspection  
Grede Foundries  
Kingsford, Michigan  
MID 006 131 890 ✓

**GREDE FOUNDRIES, INC.  
KINGSFORD, MICHIGAN  
MID 006 131 890**

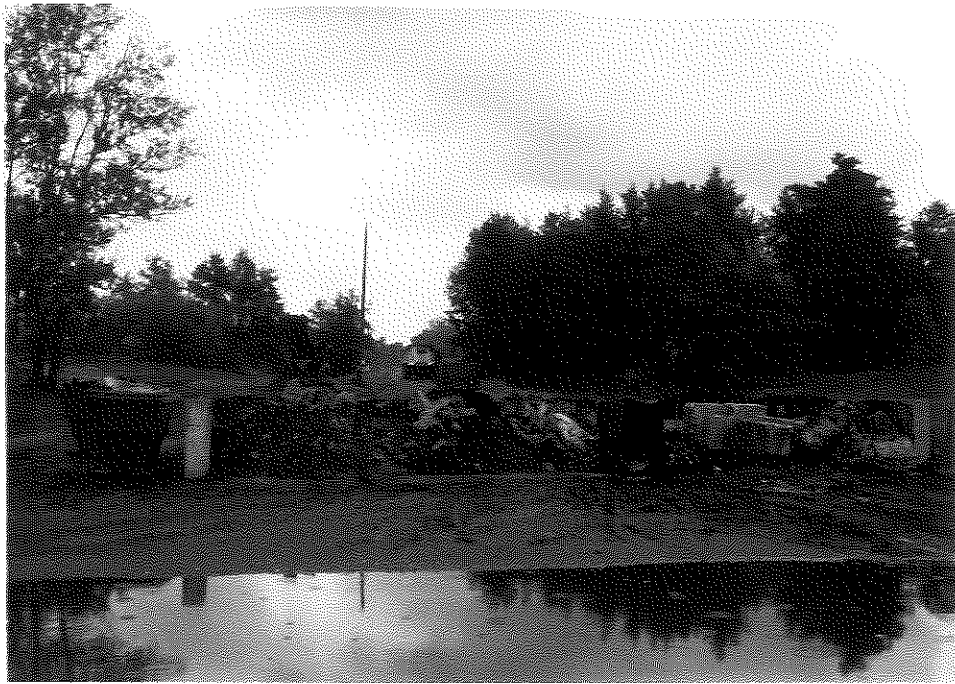
Photograph No. 1

History of Documented Release:	No releases from this unit have been documented.
Observations:	During the VSI, the unit contained cooled slag and waste sand. Molten slag is brought out to the unit in small hoppers and allowed to cool. PRC observed two hoppers of cooling slag located just north of the unit. PRC noted a large puddle of rain water in front

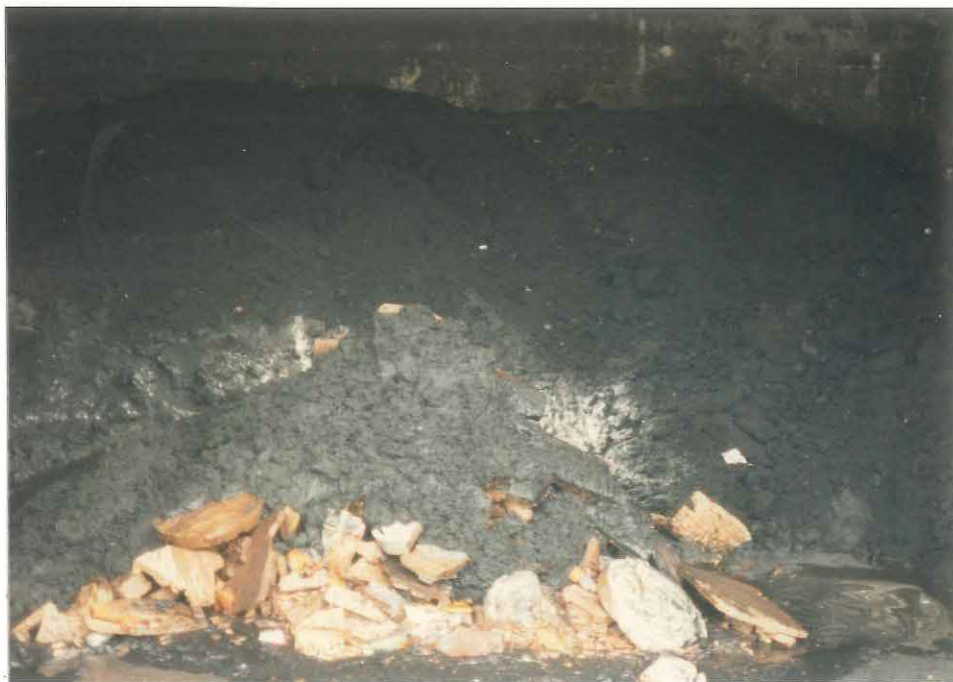
During the VSI, the unit contained broken cores, core butts, and waste sands. PRC observed that the area in front of the unit was covered with mud (see Photographs No. 2 and 3).

Photograph No. 3  
 Orientation: Southeast  
 Description: Waste contents of SWMU 2; note the standing water.

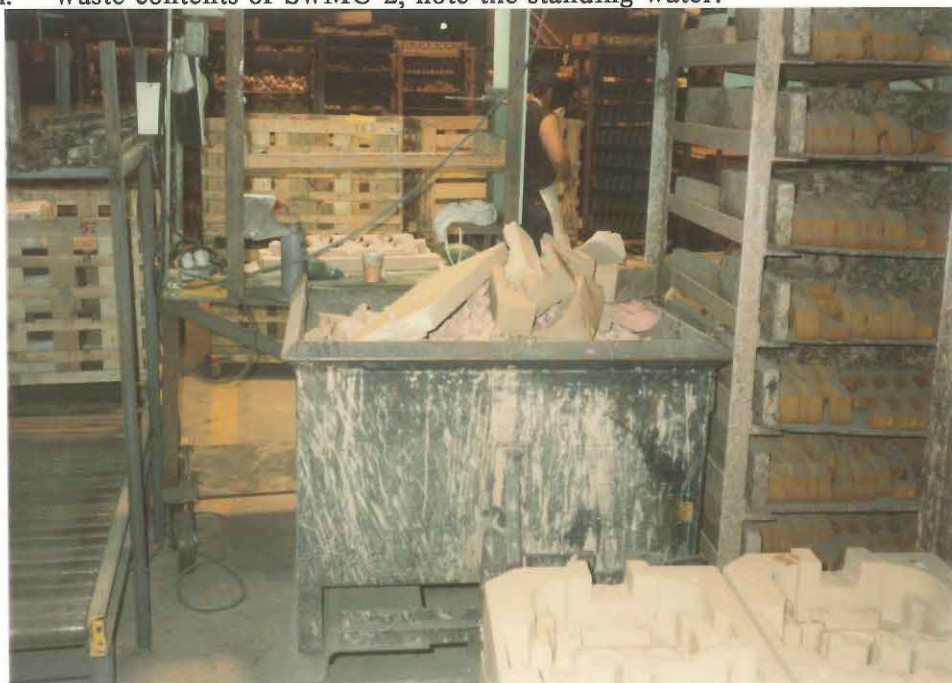
**Observations:** During the VSI, the units contained broken cores, core butts, and waste refractory. PRC noted no evidence of release (see Photographs No. 4 and 5).

Photograph No. 4  
 Orientation: South  
 Description: Satellite Foundry Waste Hoppers full of broken cores

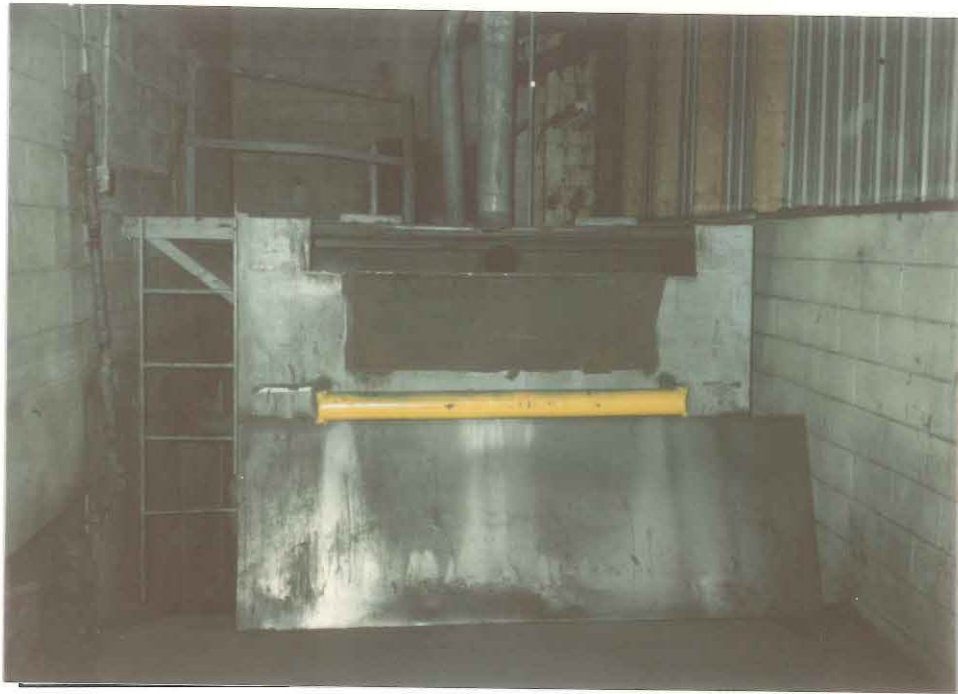
Photograph No. 6

**Observations:** During the VSI, the unit was in operation. PRC noted no evidence of release (see Photograph No. 6).

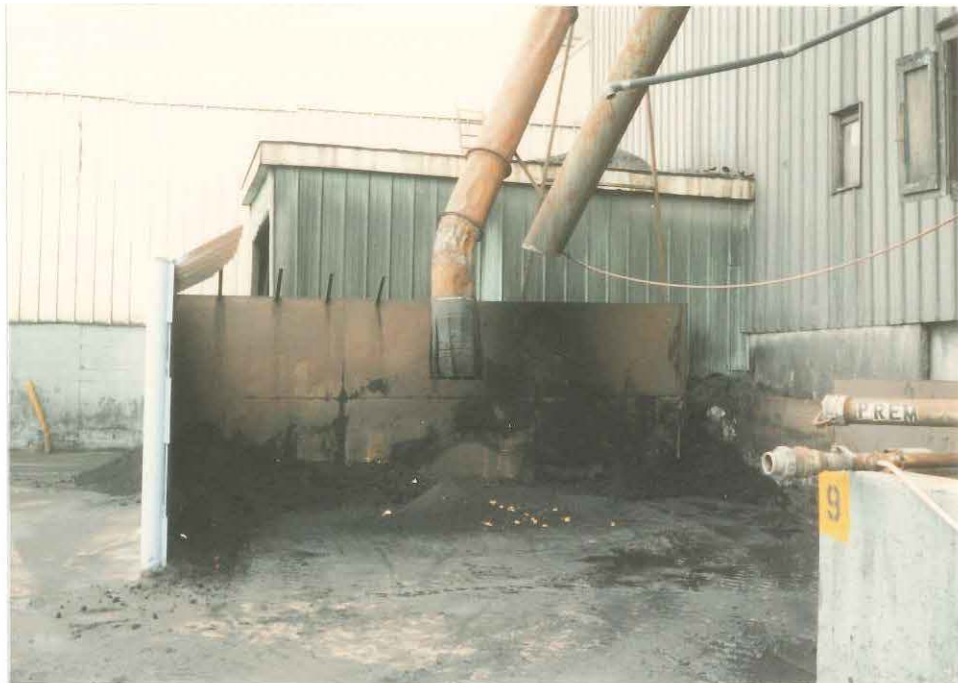
Photograph No. 7

**Observations:** During the VSI, the unit contained very little waste sand and core butts. PRC noted no evidence of release (see Photograph No. 7).

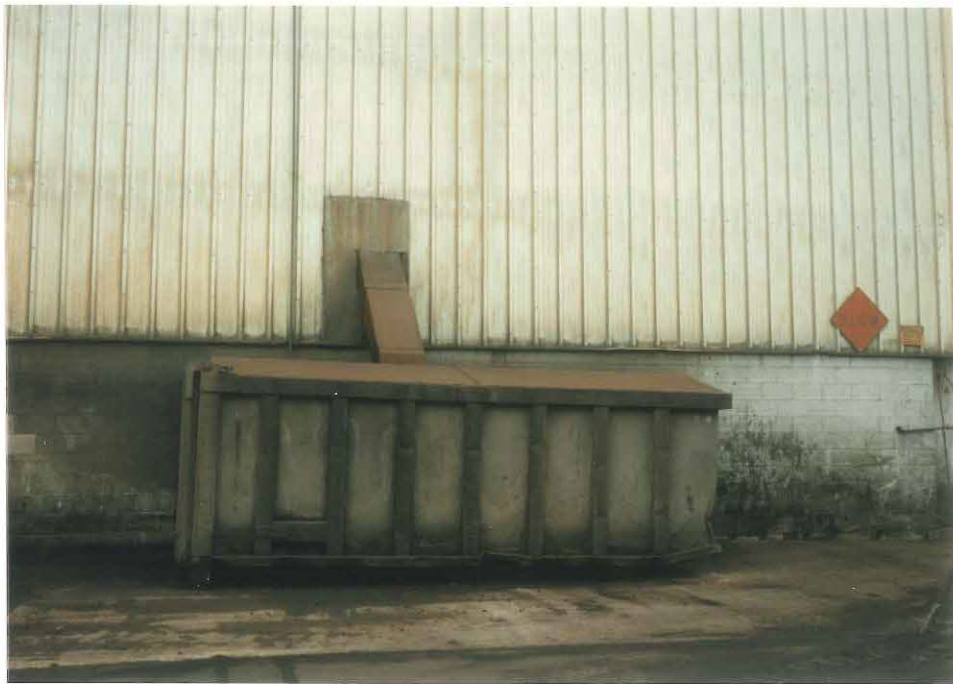
Photograph No. 8

**Observations:** During the VSI, the unit was in operation. PRC noted no evidence of release (see Photograph No. 8).

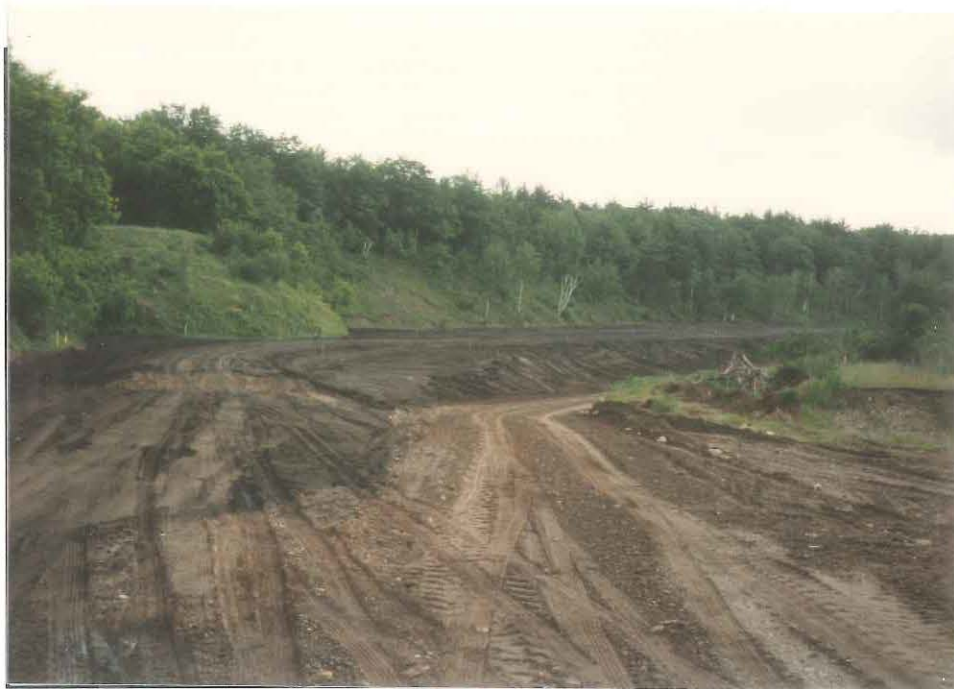
Photograph No. 11

**Observations:** During the VSI, the unit was being covered. PRC noted no evidence of release (see Photograph No. 11).

PRC recommends that the facility continue monitoring ground water at the On-Site Facility Landfill (SWMU 8) and the Former Underground Storage Tanks (AOC 1) for possible contaminant migration and that the extent of contamination around the transfer area in the Hazardous Waste Treatment System (SWMU 10) be defined for closure. PRC recommends that closure be completed for the On-Site Facility Landfill (SWMU 8) and the Hazardous Waste Treatment System (SWMU 10). Also, the inside of the Core Oil Bunker (SWMU 7) should be kept dry.

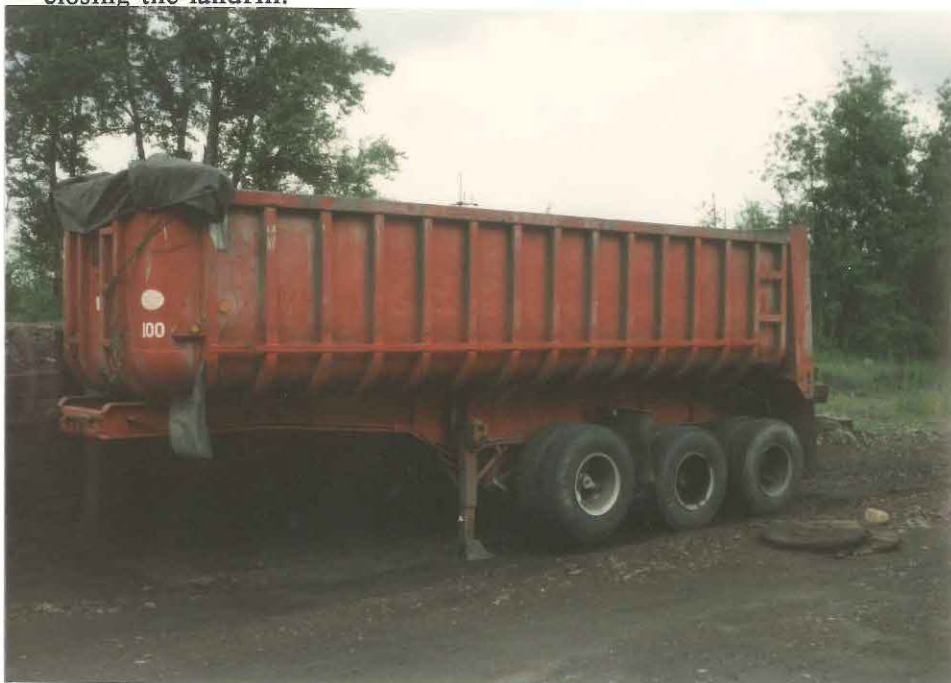
Photograph No. 12

**Observations:** During the VSI, one unit was empty, and another unit was nearly full of cupola emissions dust. PRC noted no evidence of release (see Photographs No. 12, 13, and 14).

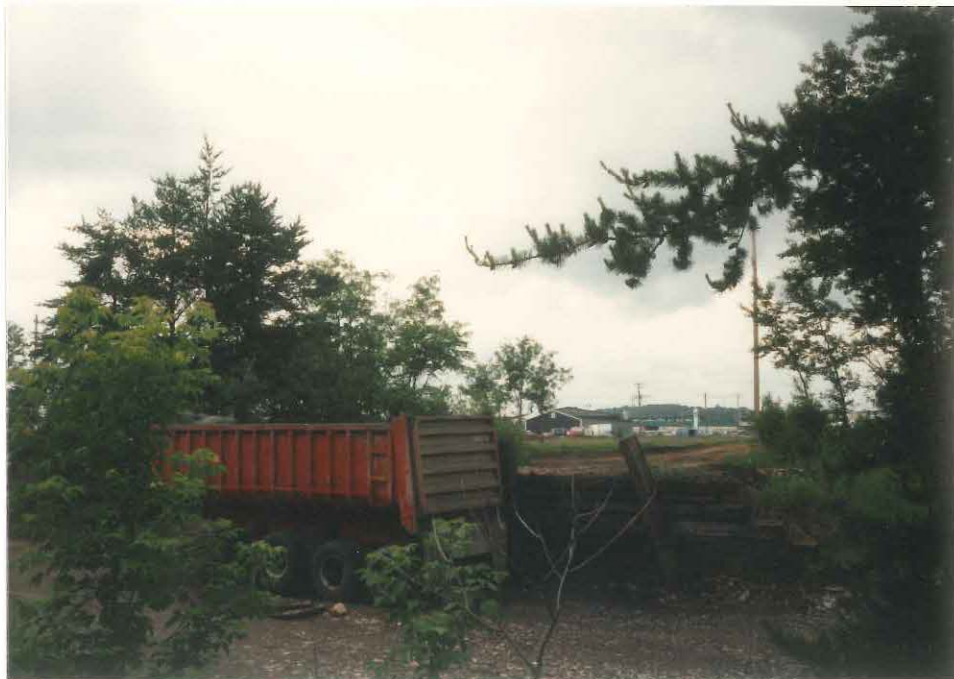
Photograph No. 15

**Observations:** During the VSI, PRC noted no evidence of release (see Photograph No. 15).

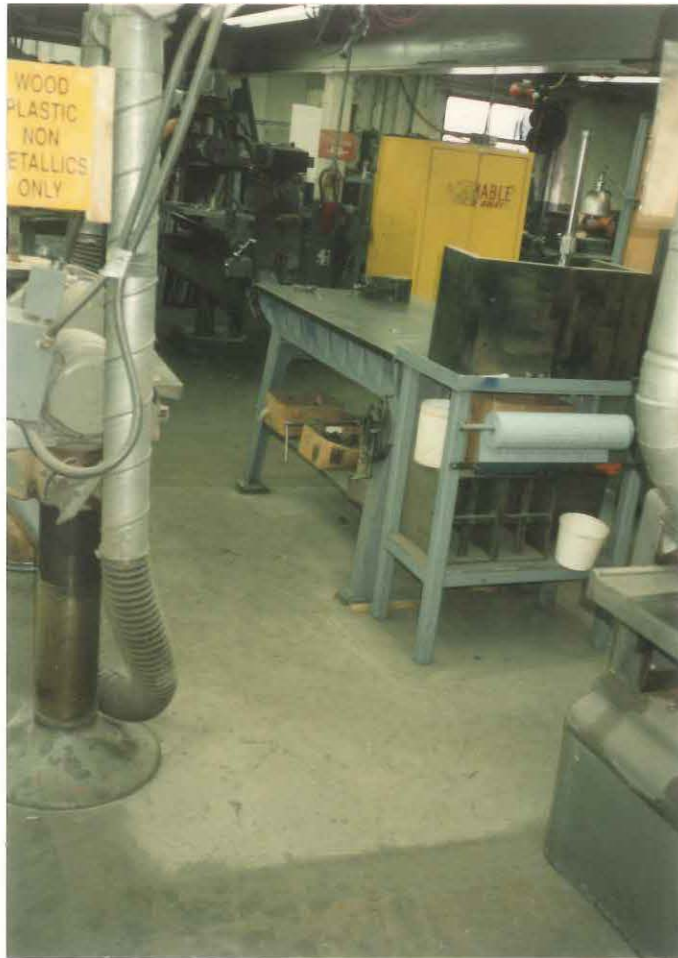
Photograph No. 16

The Former USTs were found to have leaked after in-place abandonment in early July 1990. The unit consisted of two 12,000-gallon railroad tank cars buried outside the northeast corner of the foundry building in about 1955. About 6 years later, a pattern shop was built over the tanks. The tanks stored core oil and parting oil used in the metal casting process. The units were abandoned because the facility replaced them with aboveground storage tanks. The units were abandoned in place, due to their location below the pattern shop. The tanks were cleaned and filled with sand and a sandy clay mixture between July 2 and 9, 1990. Soil sample analysis indicated contamination under the south end of the tanks. Seven carcinogenic PAHs were identified in the soil with concentrations ranging from 95 to 2,600  $\mu\text{g}/\text{kg}$ . Ground-water monitoring wells detected tetrachloroethylene and 1,1,1-trichloroethane with concentrations of 1.6 and 1.5  $\mu\text{g}/\text{L}$ , respectively. Excavation of the soil was not possible due to the location below the pattern shop's concrete floor. The facility continues to monitor contaminant migration in the ground water (MDNR, 1991e) (see Photograph No. 16).
